# OREGON FUEL INJECTION, INC.

## 6.5L DS Pump Diagnostics

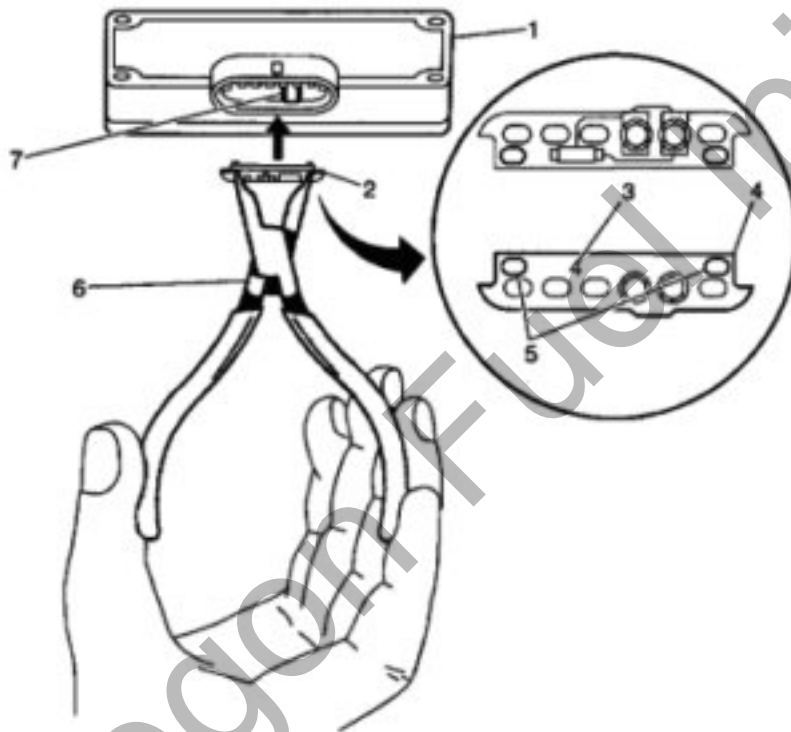
1. Fuel Solenoid Driver
2. Fuel Solenoid Driver Calibrating Resistor
3. Fuel Solenoid Driver Calibrating Resistor Identification Number
4. Fuel Solenoid Driver Calibrating Resistor Index Notch
5. Fuel Solenoid Driver Calibrating Resistor Removal Holes
6. Needle Nose Pliers
7. Fuel Solenoid Driver Index Notch for Calibrating Resistor

Removing the PMD requires a T15 TORX bit. Replace the heat transfer pad and use snap ring pliers to remove the calibration resistor. Install the calibration resistor into the new PMD.

**INSTALL FUEL SOLENOID DRIVER:** Align the mounting screws on the PMD with the holes on the injection pump (or on the remote mount PMD heat sink) Torque the mounting screws to 23 LB-IN.

**IMPORTANT: DO NOT INSTALL THE FUEL SOLENOID DRIVER WITHOUT A NEW HEAT TRANSFER PAD. DO NOT REUSE A HEAT TRANSFER PAD. USE A NEW HEAT TRANSFER PAD ONLY. THE HEAT TRANSFER PAD IS REQUIRED TO PREVENT RAPID FAILURE OF THE FUEL SOLENOID DRIVER FROM OVERHEATING.**
