OREGON FUEL INJECTION, INC.

2007.5– 2012 Dodge 6.7 L Diesel Diagnostics

High Pressure Common Rail Basic Information

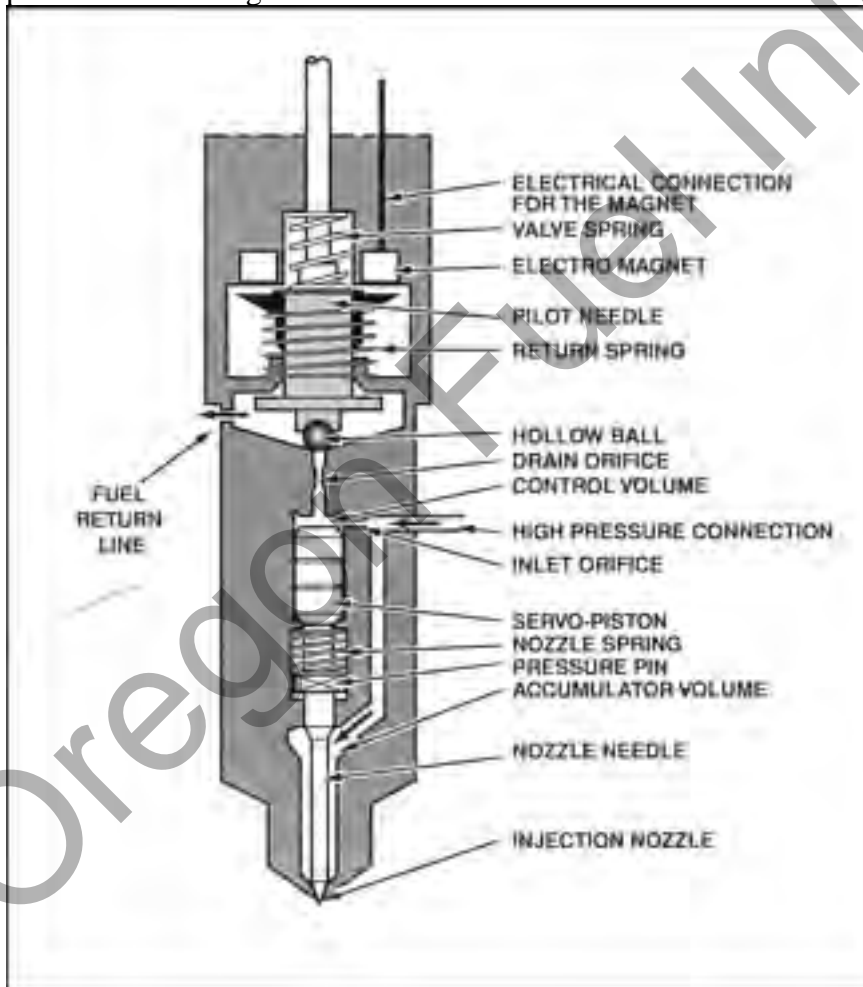
The high pressure pump builds the high pressure and delivers it to the fuel rail manifold where it flows through the injector lines and injector connector tubes to the injectors. The fuel pressure regulator (fuel control actuator) in the high pressure pump controls rail pressure. The injectors have a hollow check ball that holds rail pressure until the fuel solenoid is actuated by the ECM, this allows the check ball to rise off its' seat and an injection to take place. If the injector connector tubes, where they seat into the injectors, leak or the check ball in the injector is leaking or the high pressure limit valve then it will not build enough rail pressure to start the engine. It takes approximately 4000 PSI rail pressure for starting.
