# OREGON FUEL INJECTION, INC.

## 2001 – 2007 6.6L Duramax Diagnostics

### High Pressure Common Rail Basic Information

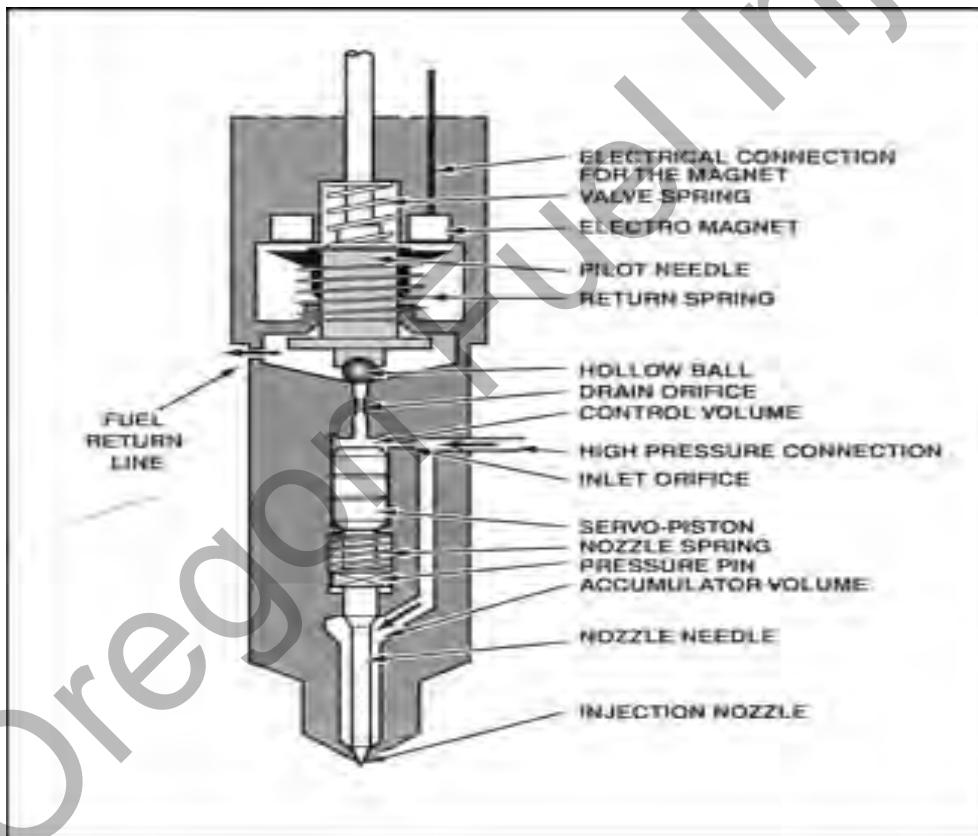
The high pressure pump builds rail pressure and delivers it to the fuel rail manifold where it flows through the injector lines to the injectors. The fuel pressure regulator in the high pressure pump controls rail pressure. The injectors have a hollow check ball that holds high pressure fuel until the fuel solenoid is actuated by the ECM, this allows the check ball to rise off its seat and an injection to take place. If the check ball in the injector is leaking due to erosion on the seat or the high pressure limit valve leaks then it will not build enough rail pressure to start the engine. It takes approximately 2500 PSI rail pressure to start.
