2007.5 – 2010 6.6L LMM Duramax Diagnostics

High Pressure Common Rail Basic Information

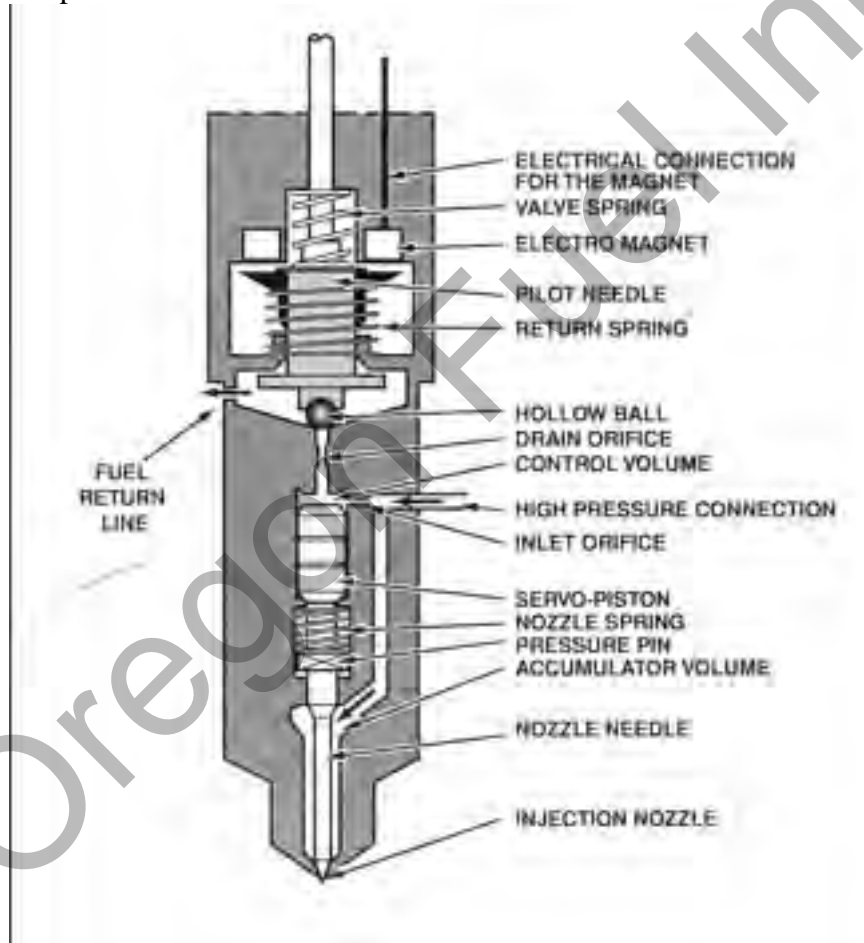
The high pressure pump builds rail pressure and delivers it to the fuel rail manifold where it flows through the injector lines to the injectors. The fuel pressure regulator in the high pressure pump controls rail pressure. The injectors have a hollow check ball that holds high pressure fuel until the fuel solenoid is actuated by the ECM, this allows the check ball to rise off its seat and an injection to take place. If the check ball in the injector is leaking due to erosion on the seat or the high pressure limit valve leaks then it will not build enough rail pressure to start the engine. It takes approximately 2500 PSI rail pressure to start.
