2005 – 2006 Jeep Liberty CRD Diagnostics

High Pressure Common Rail Basic Information

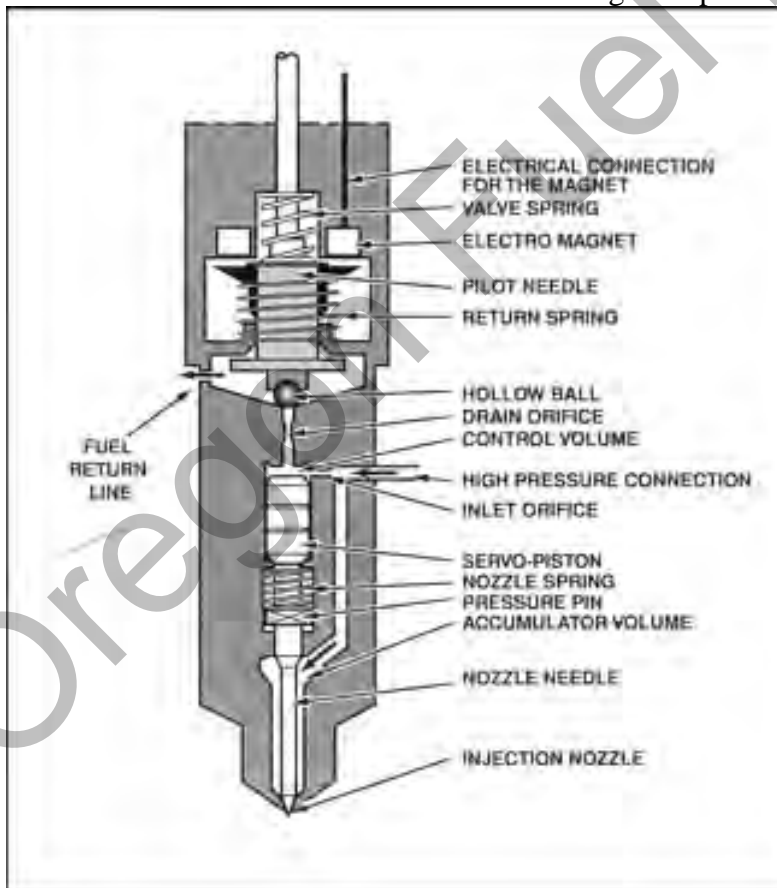
The high pressure pump builds the high pressure and delivers it to the fuel rail manifold, which buffers out pressure fluctuations and distributes fuel to the individual injectors. The fuel quantity solenoid (fuel control actuator, M-Prop) in the high pressure pump controls pressure output from the pump. The fuel pressure solenoid (pressure control valve) in the fuel rail has final control of rail pressure and prevents over pressurizing of the system. The injectors have a hollow check ball that holds rail pressure until the fuel solenoid is actuated by the ECM, this allows the check ball to rise off its' seat and an injection to take place. If the check ball in the injector is leaking or the fuel pressure solenoid is defective then it will not build enough rail pressure to start the engine.
