**INFO-02-25-2010-1**

## Installation of the Garrett® PowerMax Upgrade Turbos 773540-5001S & 773542-5001S

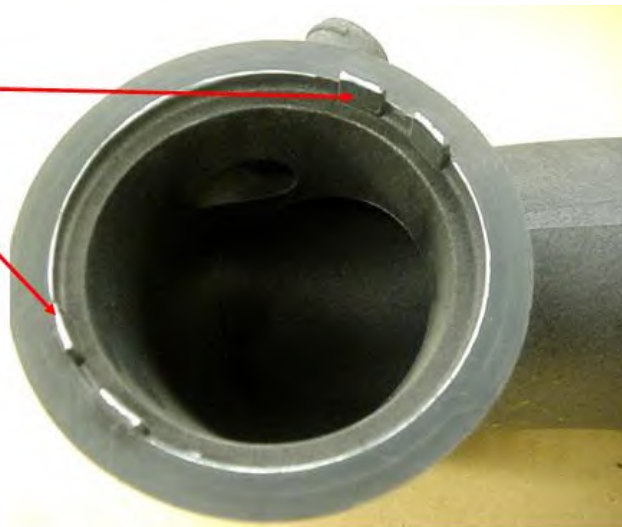
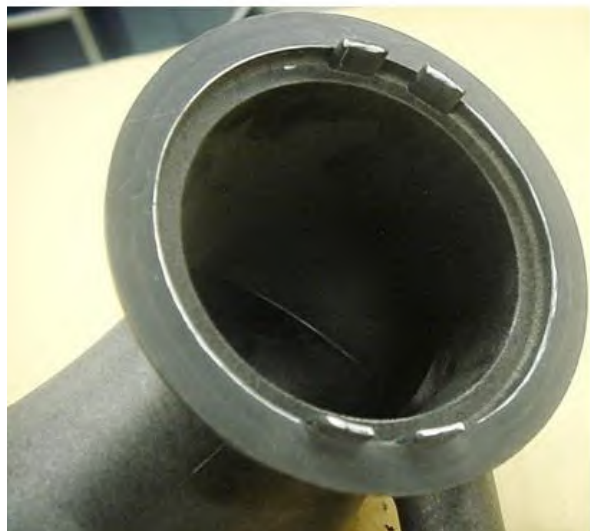
Air inlet adapter orientation tabs need to be removed for proper fit with cmpr housing inlet flange

When attaching the plastic air inlet adapter to the turbocharger's compressor housing, check the adapter for tabs on its end flange as shown in the attachment. If present, the tabs must be removed for proper fit of the adapter to the compressor housing inlet flange. There have been a variety of air inlet adapter configurations with & without tabs used over the past 5+ years of 6.6L Duramax production beginning with the 2004 LLY engines using the GT3788VA turbocharger.

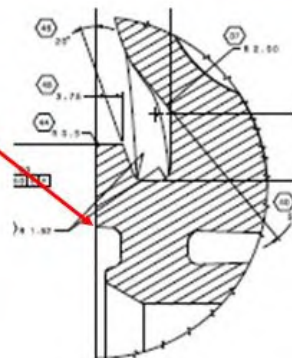
PowerMax Compressor housing inlet flange face inner diameter is slightly smaller than OE die cast housing such that tabs on air inlet adapter mating flange interfere with proper attachment of adapter to housing
